SUBJECT Hradcany (Mimon)-Airfield

I. IDENTIFICATION DATA:Reference to Enclosure #1, Overlay of []
the Hradcany Airfield.25X1
25X11. Hradcany Airfield.2. Road: Mimon \swarrow N 50-39, E 14-44 \searrow to airfield, asphalt, four meters wide.II. SITE LAYOUT:Reference to Enclosure #2, [] Sketch of the Hradcany Airfield.
(All dimensions and distances are approximate.)

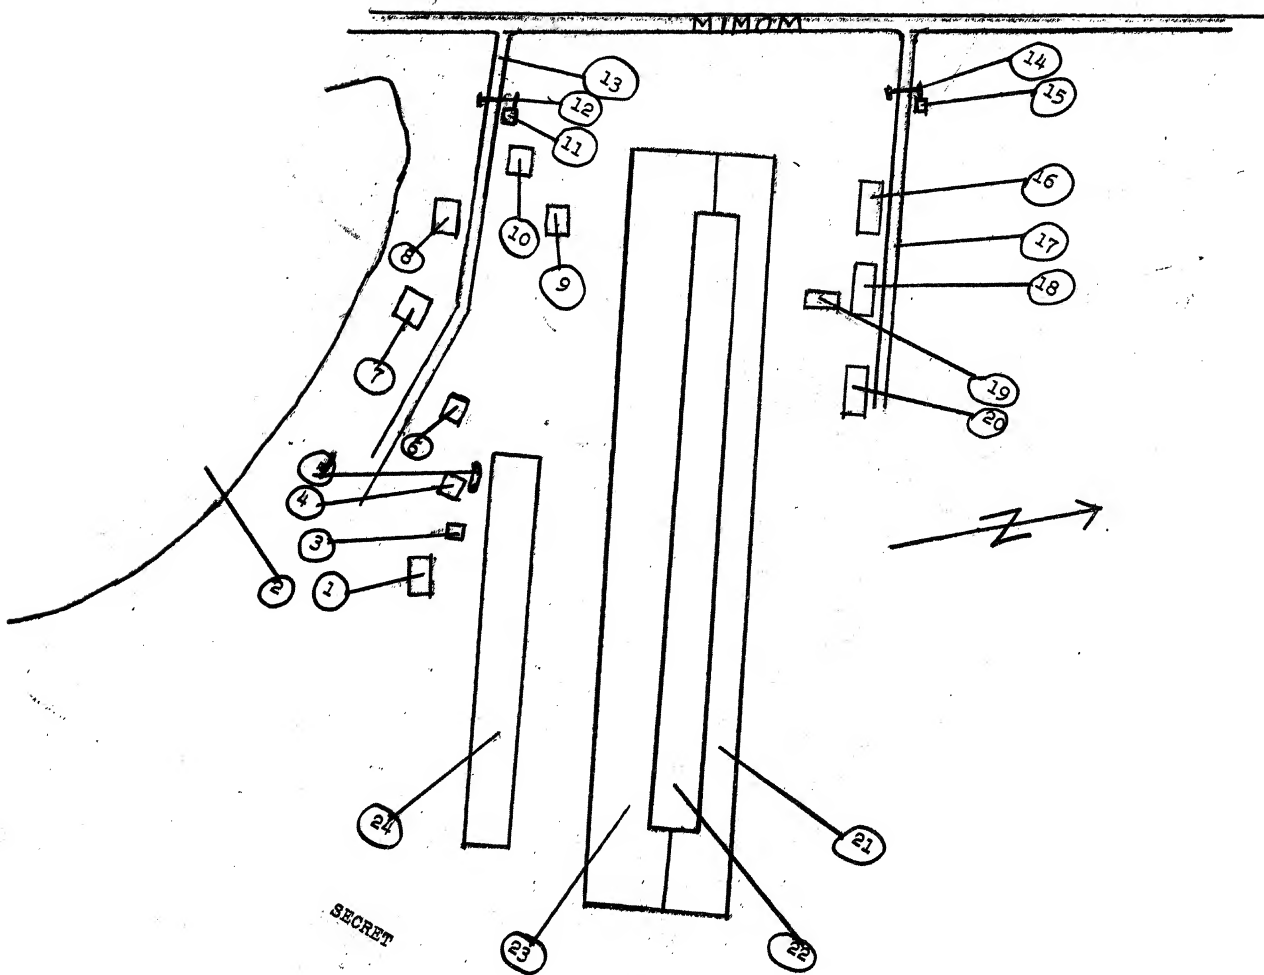
Enclosure #2,

1. Hangar. Gray, wooden, 50 m. x 25 m. x 8 m. with tar paper covered gable type roof. The front end of the hangar facing the runway was doorless. The hangar was used for housing of two Fiesler Storch, two Bieker type aircraft (number unknown) and five gliders (Zlin-25). No further information.2. Lake. Located adjacent and west of airfield. It was used for swimming during the summer and ice skating during the winter by personnel of Hradcany Airfield.

3. Weather instrument structure. White, wooden, 1 m. x 50 cm. x 50 cm., tar papered flat roof. The structure was mounted on six wooden poles, two meters high. [redacted] airmen open the door to check unknown weather instruments hourly. No further information. 25X1

4. Control tower and weather station. Two-story, white stuccoed brick, 10 m. x 10 m. x 15 m. with large glass windows 1½ m. x 1½ m. located on northeast and northwest sides of building and had a red tiled gable roof. Two wire leads from antenna (Pt. #5, Encl. #2) were observed entering second floor of the building. The second floor contained two radios of German origin (type and frequency unknown). [redacted] some unknown German words on the identification plate of the radios. Use of the radio sets unknown. This floor also contained a weather station, [redacted] The first floor was unoccupied. Three to four Air Force personnel were observed in this building. No further information. 25X1 25X1

5. Radio Antenna. Double clothes line type which was fastened to two wooden posts 9 - 10 m. high and spaced 7 - 8 m. apart.
6. Dispensary and telegraph building. Two-story, white stuccoed brick, 10 m. x 10 m. x 15 m. with red tiled gable type roof. The first floor contained a dispensary with four beds available for minor illnesses. The second floor contained a telegraph office with two telegraph keys (German origin) operated by two Air Force men. [redacted] operators sending and receiving messages (contents of messages unknown). The telegraph office operated 24 hours daily. The top of roof had an unknown type antenna. No further information. 25X1 25X1

7. Airfield headquarters, messhall and billets building. Three-story, white stuccoed brick, 12 m. x 10 m. x 20 m. with red tiled gable type roof. The basement contained an electric water pump with a steel tank (200 lit. capacity). Water was pumped from the ground. The first floor contained a kitchen and dining room for the airmen; offices for the Air Force Commandant Lieutenant HYKA, (fnu), Air Force, and an orderly room. The second and third floors contained sleeping facilities for 30 airmen. No further information.

8. Officers' quarters. Two-story, white stuccoed brick, 10 m. x 10 m. x 15 m. with red tiled gable type roof. The quarters were occupied by the Air Force Commandant and his family.

9. Officer quarters. Two-story, white stuccoed brick, 10 m. x 10 m. x 15 m. with red tiled gable type roof (roof and four sides come to a point). Quarters were occupied by a lieutenant of the paratroopers and his family. No further information.

10. Officer quarters. For description and dimensions reference is made to Pt. #9, Encl. #2. This building was occupied by a civilian forester (name unknown) and his family.

11. Guard shack. Green, wooden, one meter by one meter by two meter with tar papered gable type roof. It was occupied by one Air Force sentry armed with a 7.35 mm. Cz pistol, who controlled traffic gate (Pt. #12, Encl. #2).

SECRET
-9-
Sketch of the Hradovany Airfield.

- a. Runways (number, location, direction, length, width, surface, condition, extensibility): two runways, reference Pt. #23 and 24, Encl. #2.
b. Aprons, taxi-strips, perimeter tracks (location, size, surface, condition): There were no aprons and perimeter tracks. Taxi-strip under construction Pt. #21, Encl. #2. No further information.
c. Airfield surface: west portion of airfield was level and grass; eastern portion, level with bare ground.
d. Drainage: no information.
e. Altitude: 220-250 m. above sea level.

9. Technical facilities:
- a. Radio (transmitter masts) (give frequency): Radios reference Pt. #4, Encl. #2; radio antenna reference Pt. #5, Encl. #2. No further information.

- b. Telephone and telegraph: Field telephones were used in the buildings on the airfield, (location of switchboard unknown); Telegraph reference Pt. #6, Encl. #2; teletype machine reference Pt. #16, Encl. #2. No further information.

- c. Weather station: Reference Pts. #3 and 4, Encl. #2. No further information.
 - d. Electricity: Source of electricity unknown. 220 volts was used for the lighting system and 380 for the electric motors. No further information.
